A Methodology of Root Cause Analysis of Well Bore Failure and Lost Production Using the Well Information

2. STATEMENT OF PROBLEM: A GULF OF MEXICO CASE HISTORY

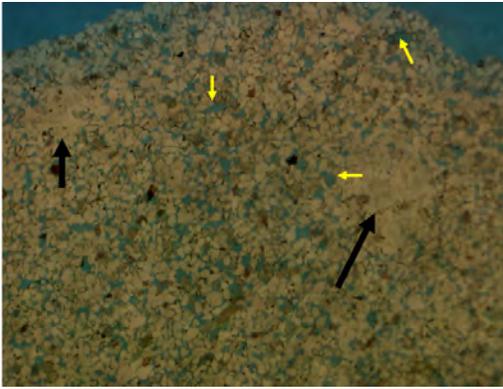
The Sandstone sample seen in Fig. 7 is a photomicrograph of a typical sandstone rock type recovered from the choke. We describe this sandstone as very fine to fine grained, well sorted, slightly clayey to relatively clean, porous sandstone with good reservoir rock quality. The primary intergranular pores are well preserved and are effectively interconnected. Some chemically unstable sand grains have been leached out completely, creating some oversized secondary pores scattered throughout the sample (yellow arrows). In this sample, the Silica quartz cemented some patches of sand grains tightly through quartz overgrowth and pore-filling mechanism. Black arrows point to two patches of silica-cemented sands. In a few of the sandstone fragments, not seen in this figure, the porosity in the entire fragment was lost to silica cement and porosity was only limited to secondary dissolution pores. This phenomenon indicates that the secondary dissolution pores post-date the irregularly distributed nodular patches of silica cementations. The pore system in general is relatively clean and free of migrating clays and swelling clays. The potential for formation damage by severe loss of permeability induced by incompatible fluids is minimal for these sandstones. However, the fluid compatibility of the **shale beds** is different from that of sandstones. Neutron porosity log shows that some of the shale beds at the Sand horizon are somewhat hydrated despite the relatively deep True Vertical Depth. Water analysis showed that the total dissolved solids in the produced formation water is in excess of 250,000ppm, as mentioned in

Fig. 7. A Reservoir rock taken from the samples of Fig. 6 for thin-section analysis of sand "C".

Upon observing the presence of the silica cement connecting sand patches of Fig. 7, we decided to investigate the "grain cementing mode" further. The Scanning Electron Microscope (SEM) image of Fig. 8 shows our further work. The figure presents the evidence of abundance of tiny secondary quartz crystals lining the pore system. We recovered this type of small crystals in the failed sandstone fragments recovered from the choke manifold. If we were dealing only with connate water saturated with silica ions, we would have expected euhedral quartz overgrowths, which form because of pressure dissolution at the grain-to-grain contacts only. It is believed commonly that overburden stress transferred to the grain contact points is the main reason for dissolution of silica in connate and pore waters. However, in these sandstones, as shown in Fig 8, we see variety of post-depositional secondary authigenic quartz developments. This phenomenon probably means that beside the interstitial connate water some free water has also been available in this rock to facilitate relatively extensive natural quartz overgrowth cementation.

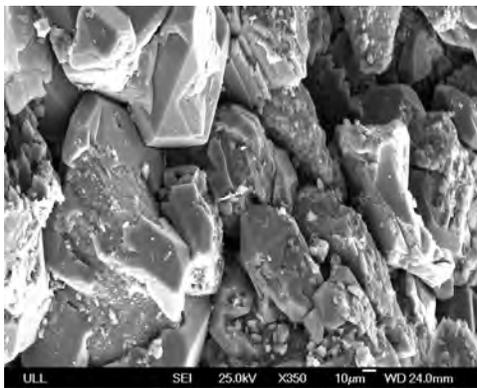
Fig.8. The Scanning Electron image of "pore filling"
In addition "authigenic" quartz overgrowth.

Upon observing some micro-fracture in Fig. 8, we decided to investigate the rock failure mode of sand "C". Fig. 9 shows the area of interest to us. The rotated, oriented, and arc-like sand grains suggest the Reservoir rock failure is due to the effects of Reservoir subsidence. Interestingly, this is where we find a large

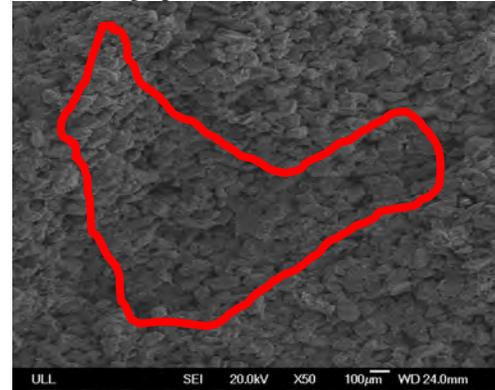
number of fractured Reservoir Rock grains not shown in this image.

Fig.9. A failed Reservoir rock fragment produced from the perforated section of sand "C".

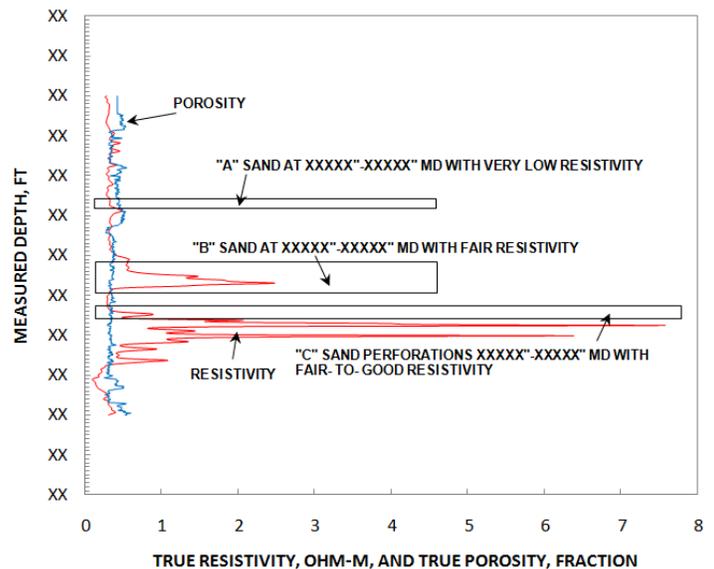
(a) The best quality reservoir is found within the top section of "C" sand where data indicates a strong Density Porosity-Neutron Porosity cross over with much higher true Resistivity than other sands. Our analysis of True Porosity of this section indicates that in this particular zone, on average, the porosity is about 25 percent. The porosity plot along with True Resistivity data for this sand is shown in Fig. 10.

Fig. 10: Resistivity and Porosity of all sands.

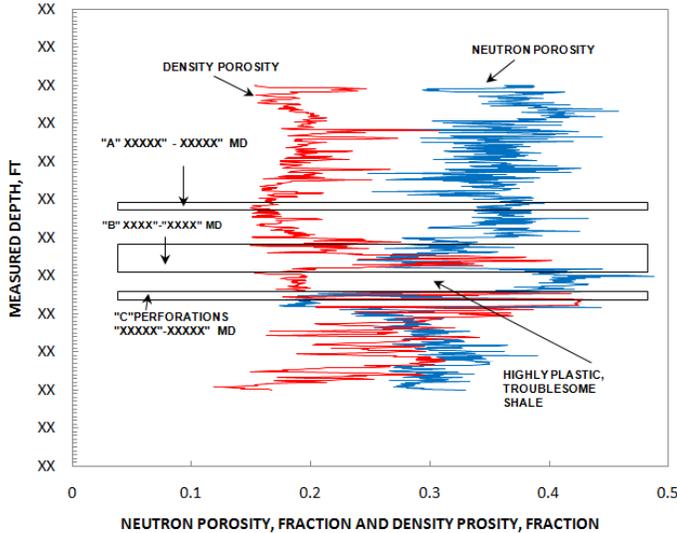
(b) We have provided the porosity crossover plot, which commonly serves as a method of locating "gas" rich pay zones. This is shown in Fig. 11. The interesting feature of this figure is the "shale" section immediately above the sand "C" where shale appears to contain an unusual amount of water.

Fig.11. Neutron and Density porosity crossover plot of all sand

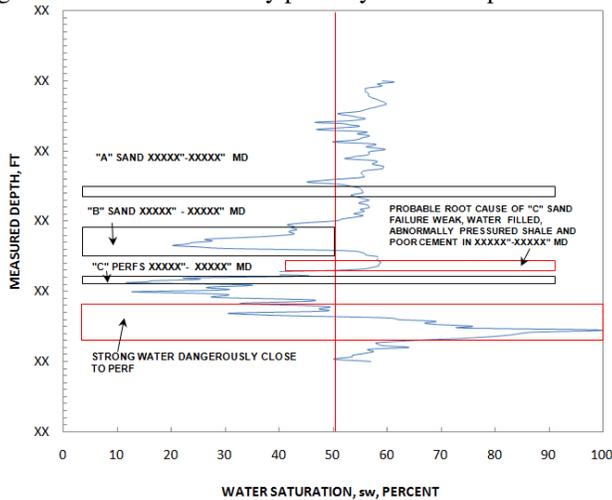
(c) Comparing the high water saturation in shale with the water saturation in sand "C" we find sand "C" S_w is less than 50 percent. We show the water saturation profile in Fig. 12. As far as the probability of the hydrocarbon production is concerned, by far the "C" sand member is the best among other members. However, because of the high amount of water in the shale lying immediately above the "C" sand, we cannot make the same claim for the stability of the well bore or the perforations in this particular sand. Furthermore, a close examination of Fig. 12, and keeping Figures 2, 3, 4, and 5 in mind, leads the authors to suggest that the failed shale and cement samples shown in these figures are most likely from "C" zone. We show further evidence in support of our observation when we discuss the *Input* data.

Fig. 12. Water saturation profile of all sand members.

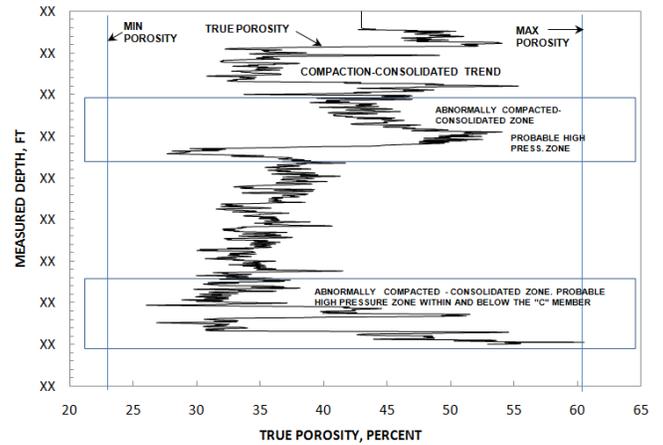
(d) Finding the evidence of "high" water saturation and high pressure water zones near the failed sand "C" perforation prompted us to examine the trends of compaction-consolidation for all formations. Fig. 13 shows the porosity plot with measured depth. The concept of effective stress theory mentioned previously teaches us that for small strains *the time rate of change in effective stress is equal to a factor multiplied by the change in formation pressure (pore pressure) with respect to thickness of the sand, where the thickness of the sand is based on*

the True Vertical Depth of the sand. The small strain here means actually small changes in porosity or void ratio. Now within the context of *"highly water saturated weak shale" lying above and below the "C" sand, it should be obvious that a "high rate of pressure and production decline" must lead to mobilization of shale/cement/perforation tunnels toward the well bore, thus causing "lost production".*

Fig.13. The Formation consolidation-compaction trend.

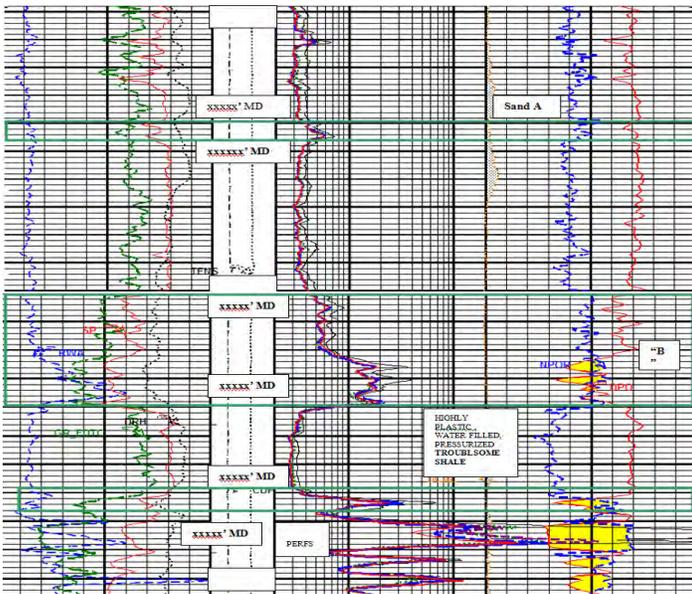
The next piece of evidence we analyzed were the well logs. Fig. 15 shows the well log. The well log shows all three members, A, B. and C. The most important piece of information regarding the well bore failure is the quality of shale lying above the "C" sand. Comparing the Neutron Porosity (the blue trace) immediately above the "C" sand with the shale above "B" and "A" members reveal that the shale above "C" contains a much larger proportion of water than the shale above "B" and "A". In fact, it appears that the shale above "B" is much "different" from the other shale sections. *The shale we received several months ago, Fig. 2, as of the date of writing this paper, still contains a high amount of water and still is liberating gas.*

The continued gas liberation from the shale sample, suggests that the "cement" should "bond" very little or should not "bond" to it at all. Following the chain of evidence and, in order to find further supporting data regarding the "flowing failure" of the highly plastic (gumbo) shale and the subsequent "C" sand failure, we analyzed the Cement Bond Log and the Variable Density Log from this well.

Fig. 15: The Well log from a well in Gulf of Mexico.

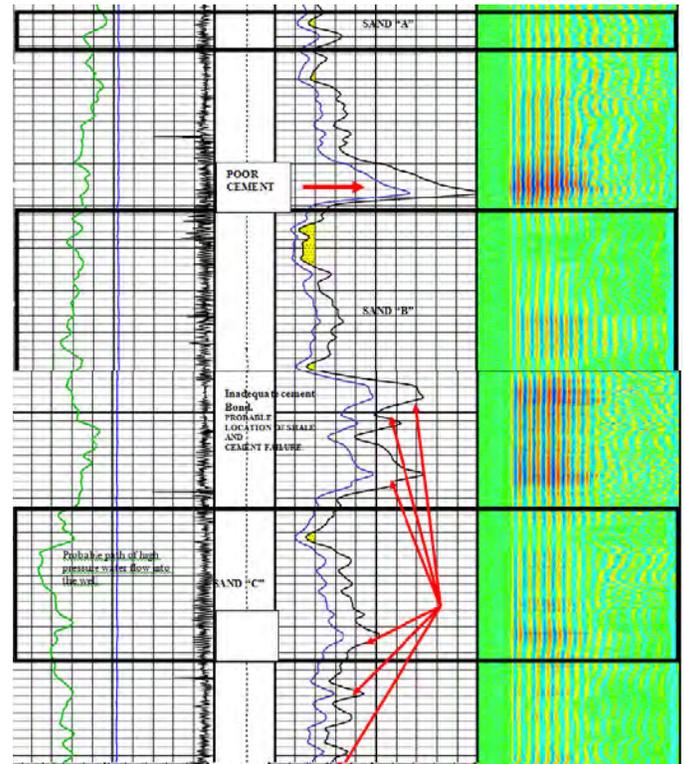
Fig. 16 shows the CBL/VDL data from the well in question. The important features of the data, which support our previous failure analysis, are: (1) the red arrows above the "C" sand point to CBL where there is "little" to "no cement bond" to the casing and (2) the VDL shows little "cement" bonding to the formation. The reader may recall that the red arrows above the "C" sand in this figure definitely point to the highly plastic (watery gumbo shale) "gassy" shale in showing high Neutron Porosity in Fig 15. In short, this evidence pinpoints the "failed shale" flow path toward the "C" sand. And, this concludes our well forensic analysis set forth in Fig. 1.

Fig. 16. The Cement Bond Log/Variable Density Log

d.   The CBL/VDL log, shows the existence of poor cement bond above the "C" sand. The high-pressure shale with high water content and dissolved gas obviously did not allow the cement to develop any significant bond to the casing and the shale formation (watery, gassy, gumbo shale.) We believe this is the source of shale and some small amount of cement fragments entering the well bore and tubing, after being broken down due to subsidence and water invasion. We attribute the cause of subsidence to producing the "C" sand at high rates. It appears the well was perforated without any strong cement supporting the casing. Actually, we do not see any evidence of any reasonable water isolation that cement is supposed to provide for protecting the "C" sand.
